January 26, 2011

Waste Management of Hawaii  
Waimanalo Gulch Sanitary Landfill  
92-460 Farrington Highway  
Kapolei, Hawaii 96707

Subject: Liner Damage Assessment and Construction Quality Assurance Report for Cell E-6 and E-4 Repairs, Waimanalo Gulch Sanitary Landfill, Kapolei, HI

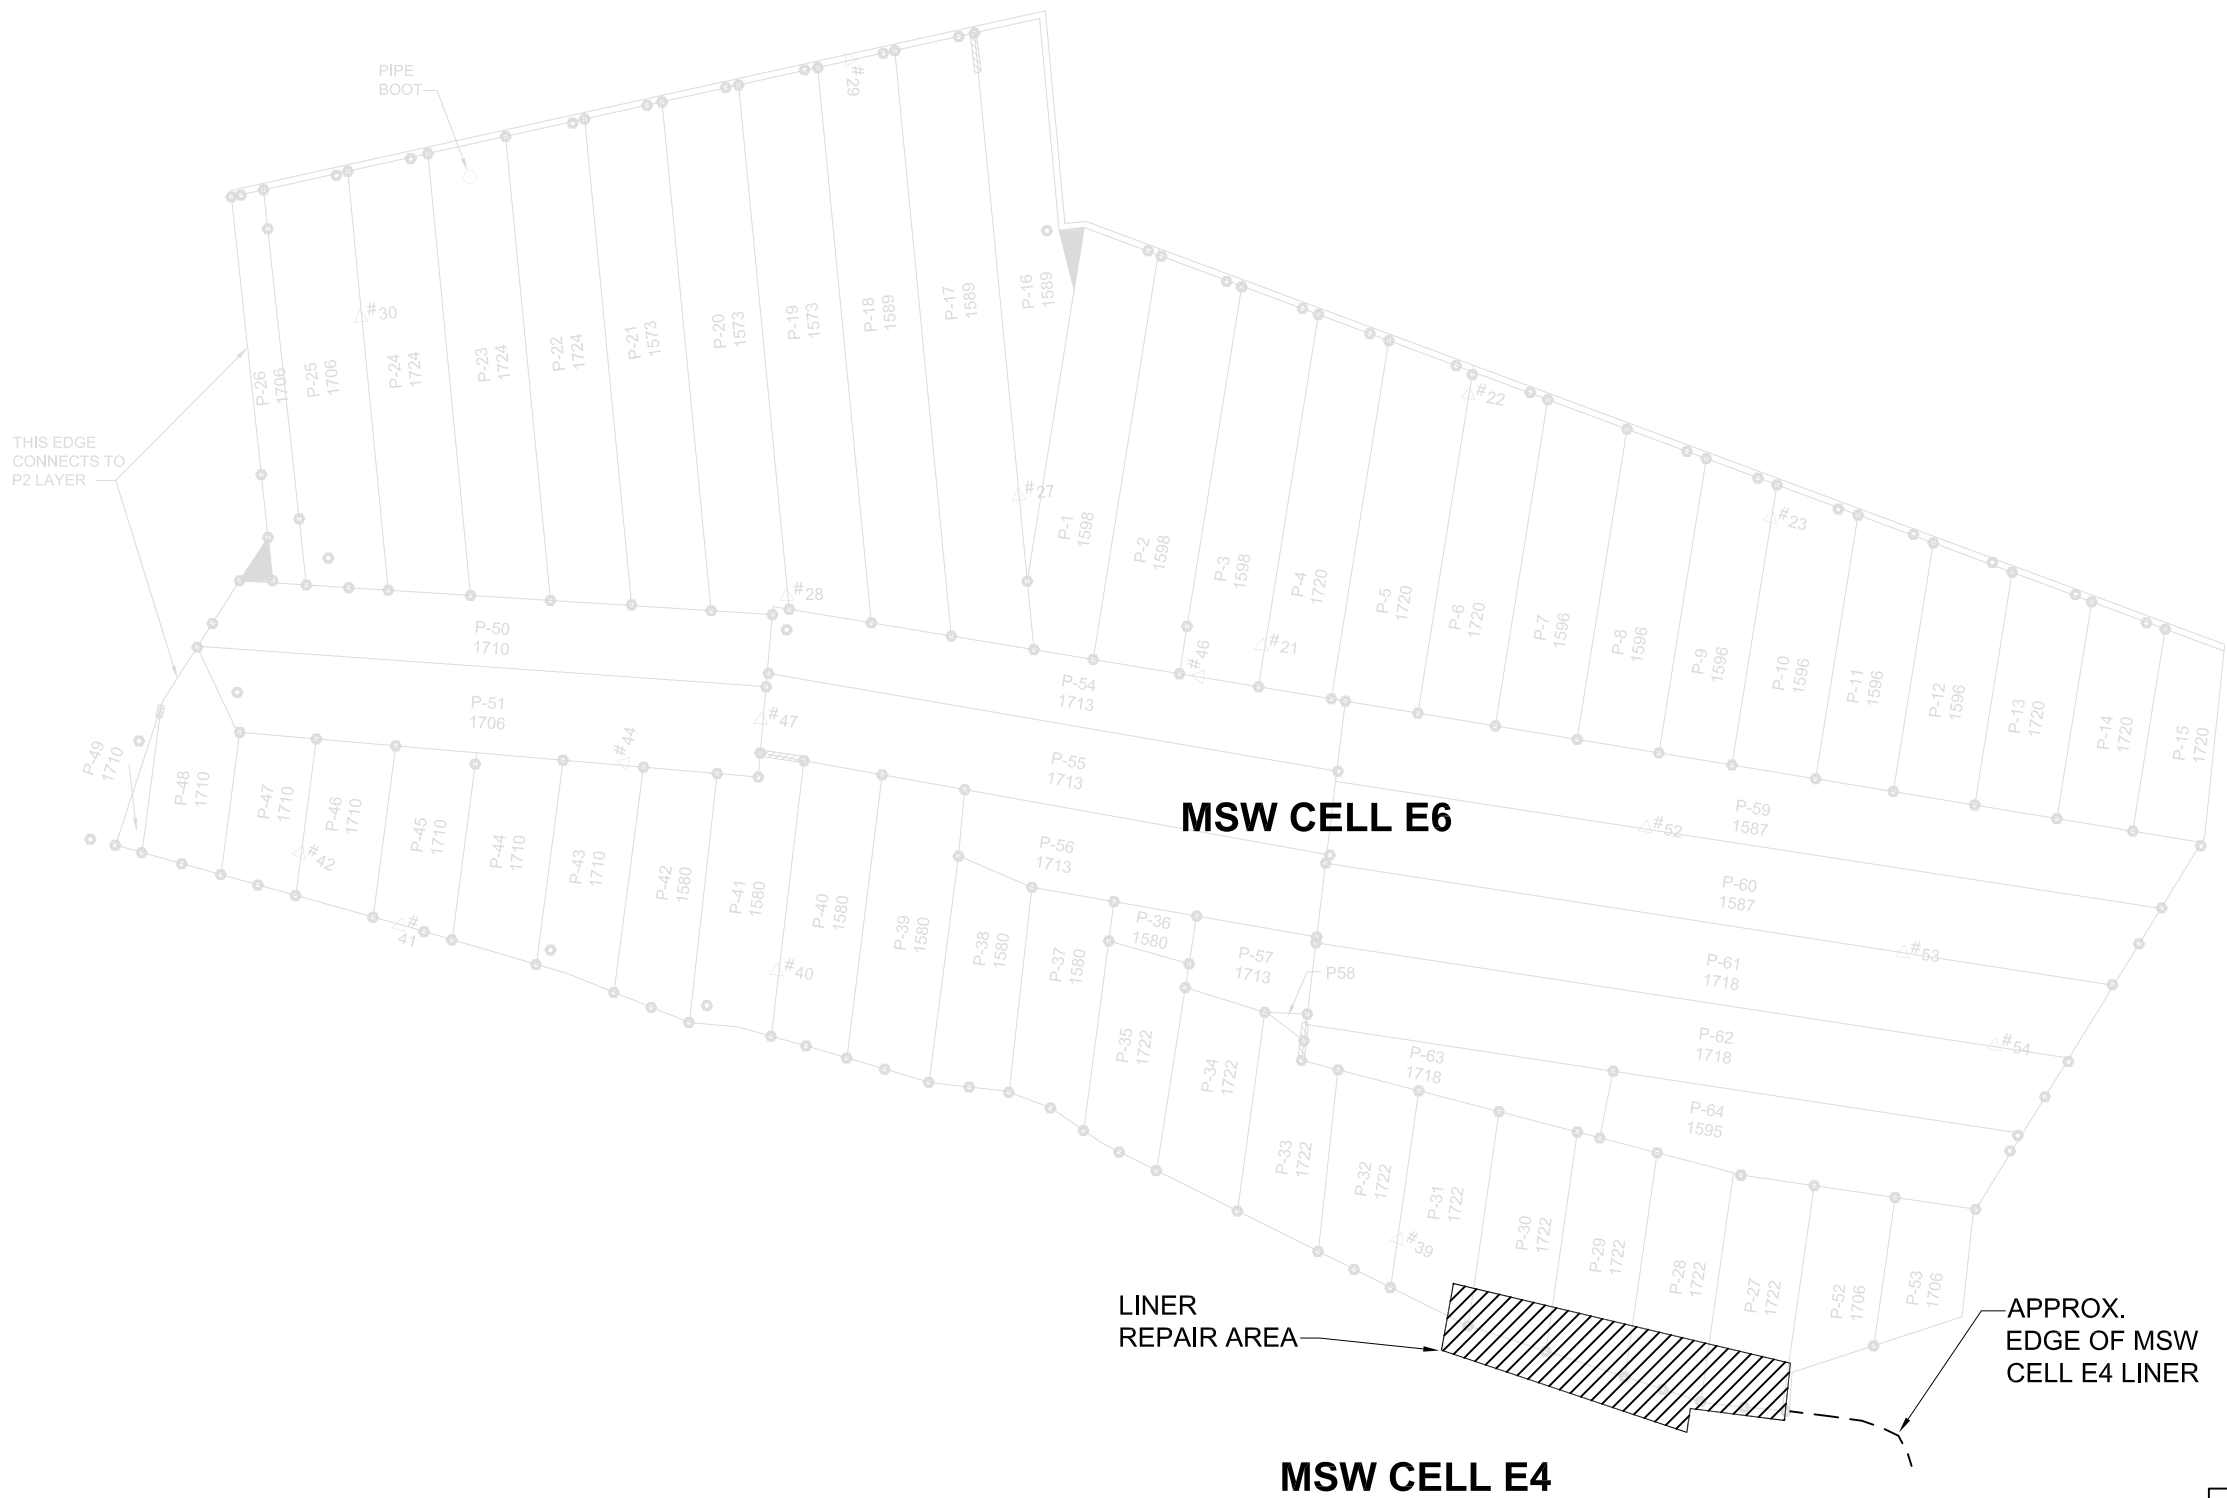
**Figure 2**  
**Repair to MSW Cell E6 and E4 Liner**  
**January 2011**

layers of liner to determine if the underlying geosynthetic clay liner (GCL) had been hydrated and whether the subgrade cushion soil was intact. This uncovering process continued to the south, east, and west until undamaged layers and suitable subgrade soil were exposed. The area requiring repair is shown on Figure 2, Attachment 1.

The repair area is shown on Figure 2 in Attachment 1. The area is along the northeastern edge of Cell E6, corresponding to originally installed panels P-27 through P-31 (60-mil panel numbers), and is approximately 60-ft long in the north-south direction and 30-ft wide in the east-west direction. Approximately half of the repair was to the E4 liner system (60-mil high-density polyethylene [HDPE] over GCL) and the other half to the E6 liner system (60-mil HDPE over GCL over 40-mil HDPE). The tie-in weld between the E6 liner system and the E4 liner system was constructed in accordance with the project specifications.

Hydrated or otherwise damaged GCL was replaced in the designated repair area shown on Figure 2. The GCL was deployed in a manner not to entrap stones or other loose soil under the material. All adjacent panels of new GCL were overlapped a minimum of 18 inches and bentonite was applied at a rate of 1/4 pound per ft of seam. The Cell E6 GCL was connected to the Cell E4 by overlapping a minimum of 36 inches.

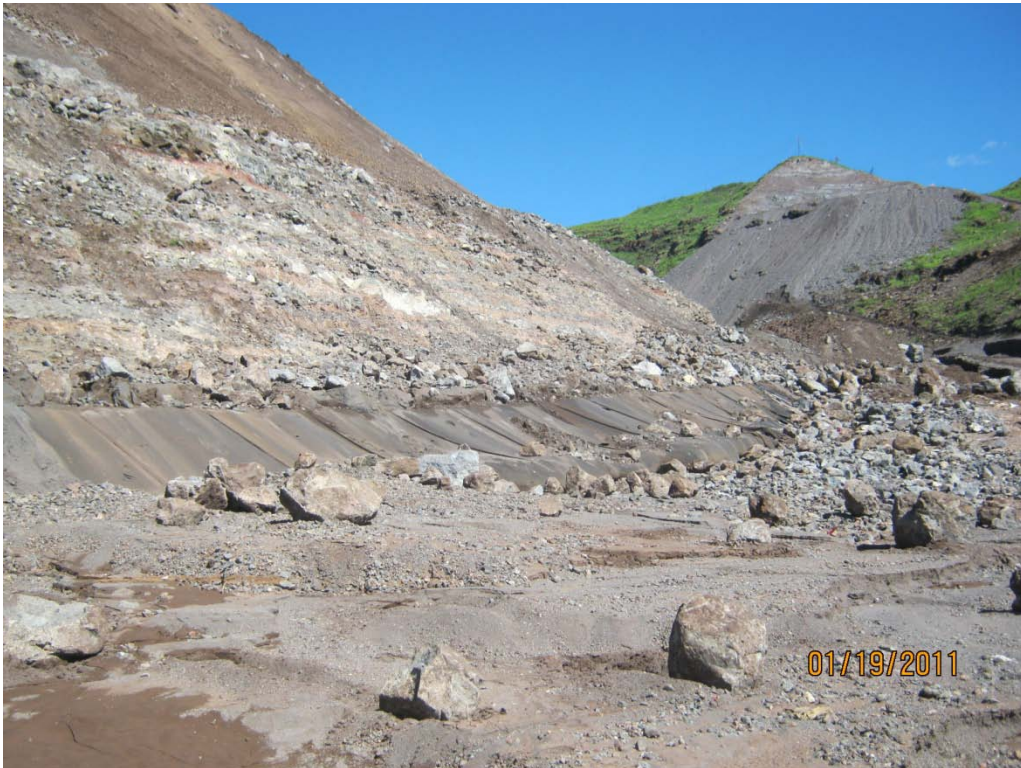
This letter report focuses on the damage to the edge of the liner system where MSW Cell E6 joins with E4. It is our understanding that the damaged western slope area of Cell E6 will be investigated at a later date. The high flows and sloping topography in the area at the Cell E6/E4 tie-in resulted in erosion and exposure of the leading edge of the liner. The high flows caused the leading edge to fold upward allowing rocks and debris to accumulate on top and underneath both Cell E6 and E4 liners, as well as tearing the composite liner in multiple locations.

Photo 1. Storm damage to Cell E6, western slope.

Due to obvious liner damage to the western slope of MSW Cell E6, future MSW placement operations should be kept at least 50 ft away from this slope area to allow liner repair work to be completed.

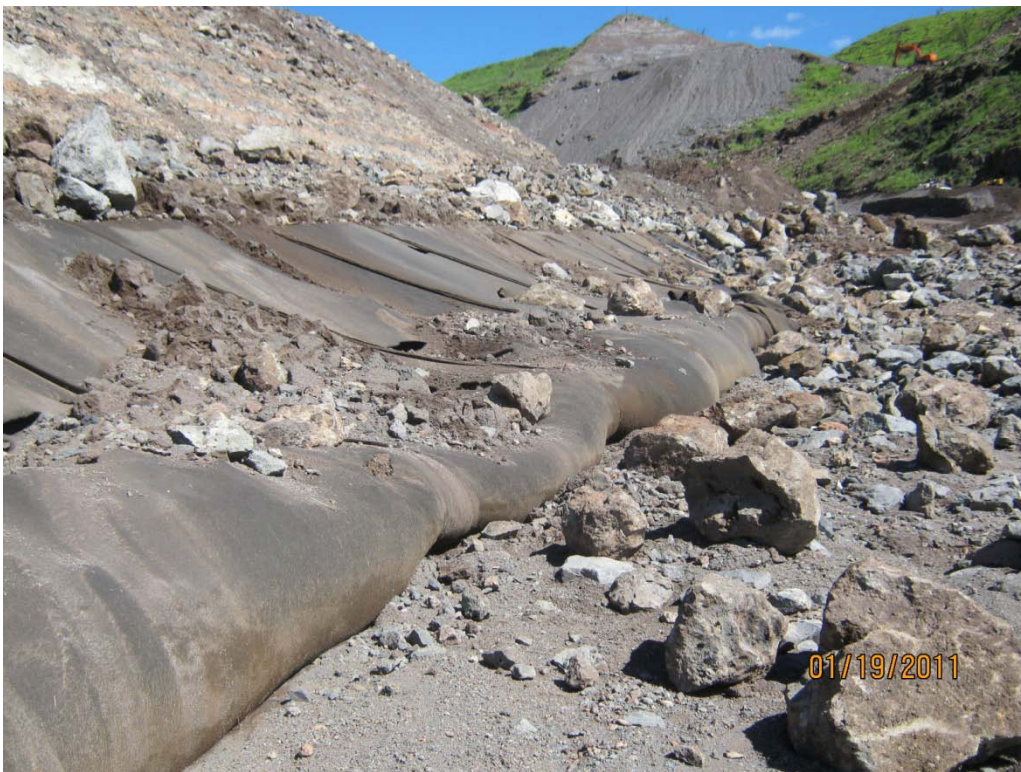
Photo 2. Storm damage to Cell E6, western slope, close-up.

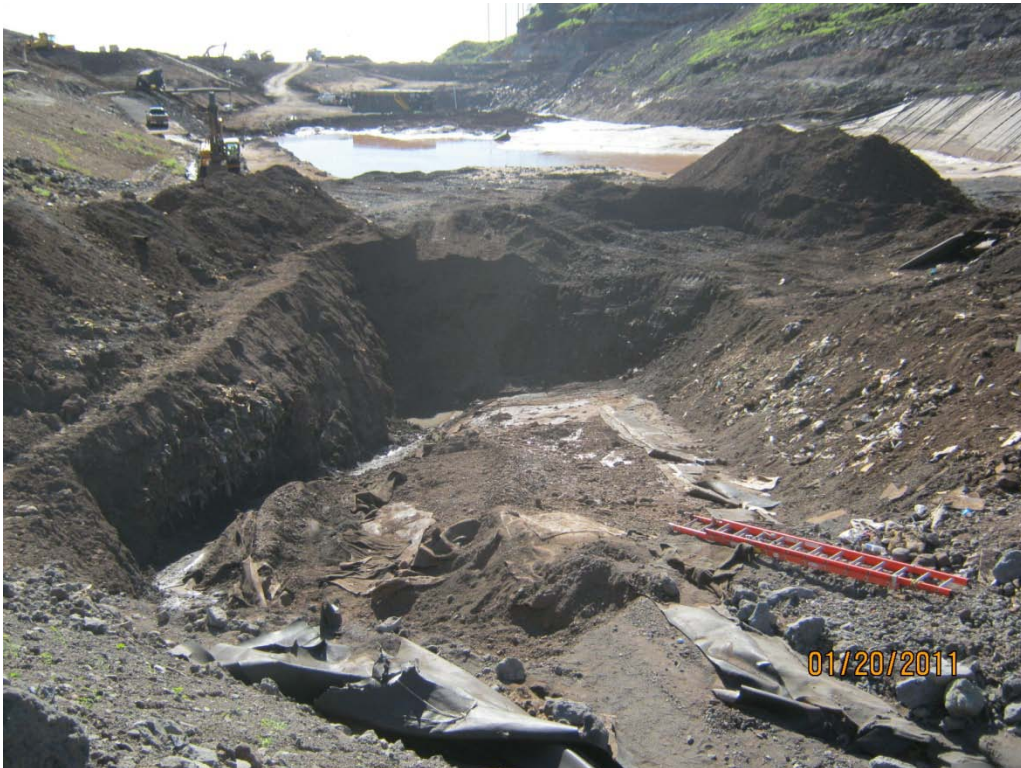
In late December 2010, a series of storms produced high runoff resulting in damage to the northwestern (up-canyon) edge of the floor MSW Cell E6 liner system where it joins with MSW Cell E4. In early January, work began to expose the edge of liner to observe the extent of damage. However, before this work could be completed, a large storm arrived on evening of January 12, 2011 that resulted in severe flooding of the landfill and caused additional damage to this area as well as to the exposed western slope of the Cell E6 liner area. The damaged areas are shown on Figure 1, in Attachment 1. Photos of the damaged areas are presented in Attachment 2.

Photo 3. Storm damage, Cell E6/E4 tie-in, looking southwest.

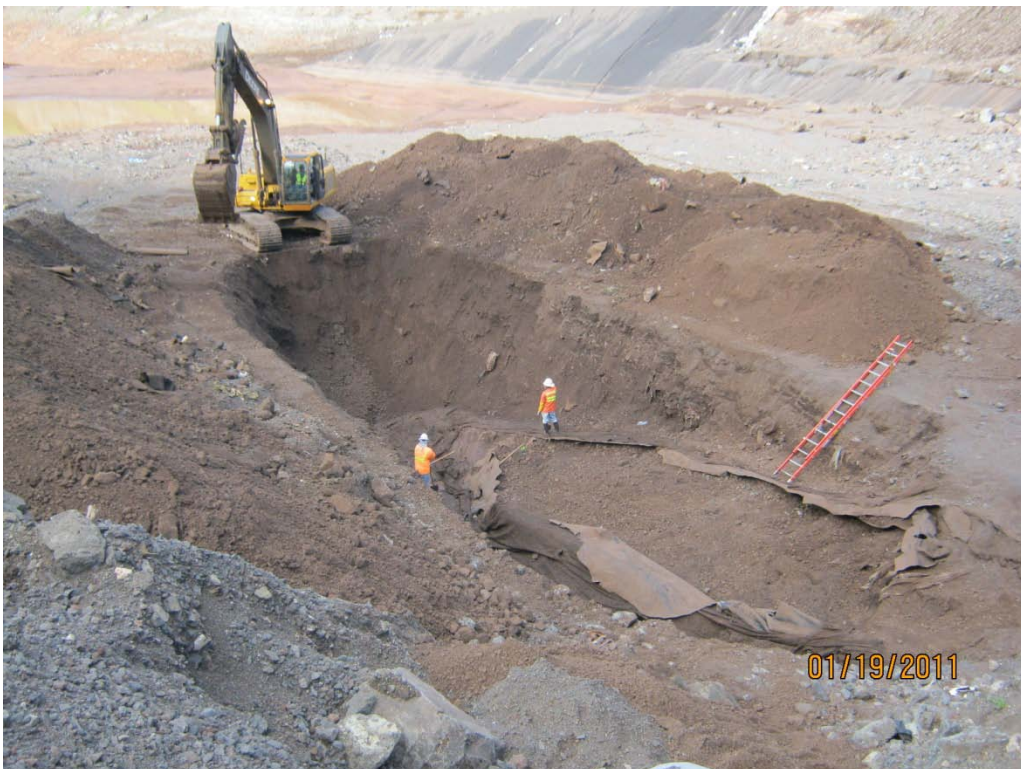
Photo 4. Storm damage, Cell E6/E4 tie-in, looking west.
